***Libby & Woodman and Chick Mill (27-CA-170)***

**Libby & Woodman and Chick Mill (27-CA-170)  
Chronology and Evolution**

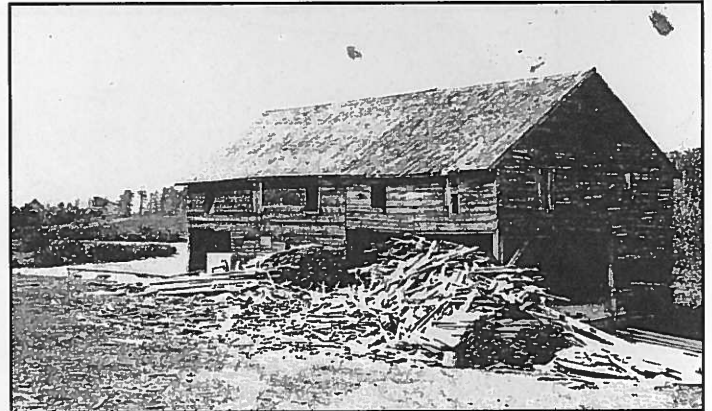
*A historic photograph of the wooden-framed Chick's Mill and lumber yard. The mill pond is to the left. Logs stored in the pond were drawn up a ramp on the left end. Sawn lumber was removed on the right end, and waste was tossed through the opening on the side.*

The Chick mill and dam endured floods and demise, continuing to saw lumber into the 1930s before it collapsed. The dam created a mill pond that was used to store logs and which provided power into the mill building. The turbine, an innovation of 1848, reflected an up-to-date approach to milling and was probably in use during the 1850s mill operation. Historic photos attest to the quantity of lumber processed at the mill, depicting logs being hauled by horse, logs stored in the pond, and stacks of material in the lumber yard adjoining the mill.

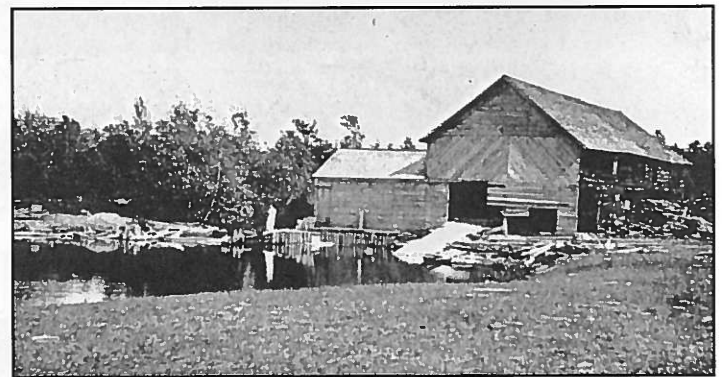
*A second historic photograph view of Chick's Mill from the mill-pond side. The dam is to the left of the ell that rests on it. (Both of the historic mill photographs are after Wakefield-Brookfield Historical Society 2006:90.)*

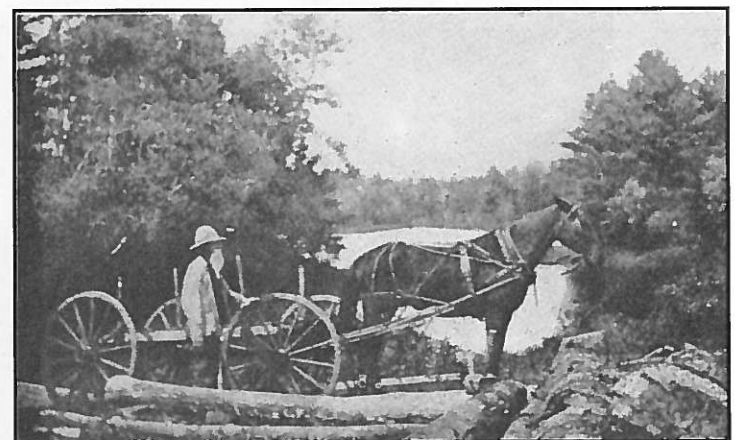
*A historic photograph showing a method of hauling logs to Chick's Mill (after MacRury 1987:123).*
